DRINKING WATER LEAD SAMPLING

HENLEY HIGH SCHOOL

8245 HWY. 39, KLAMATH FALLS, OREGON

KLAMATH COUNTY SCHOOL DISTRICT

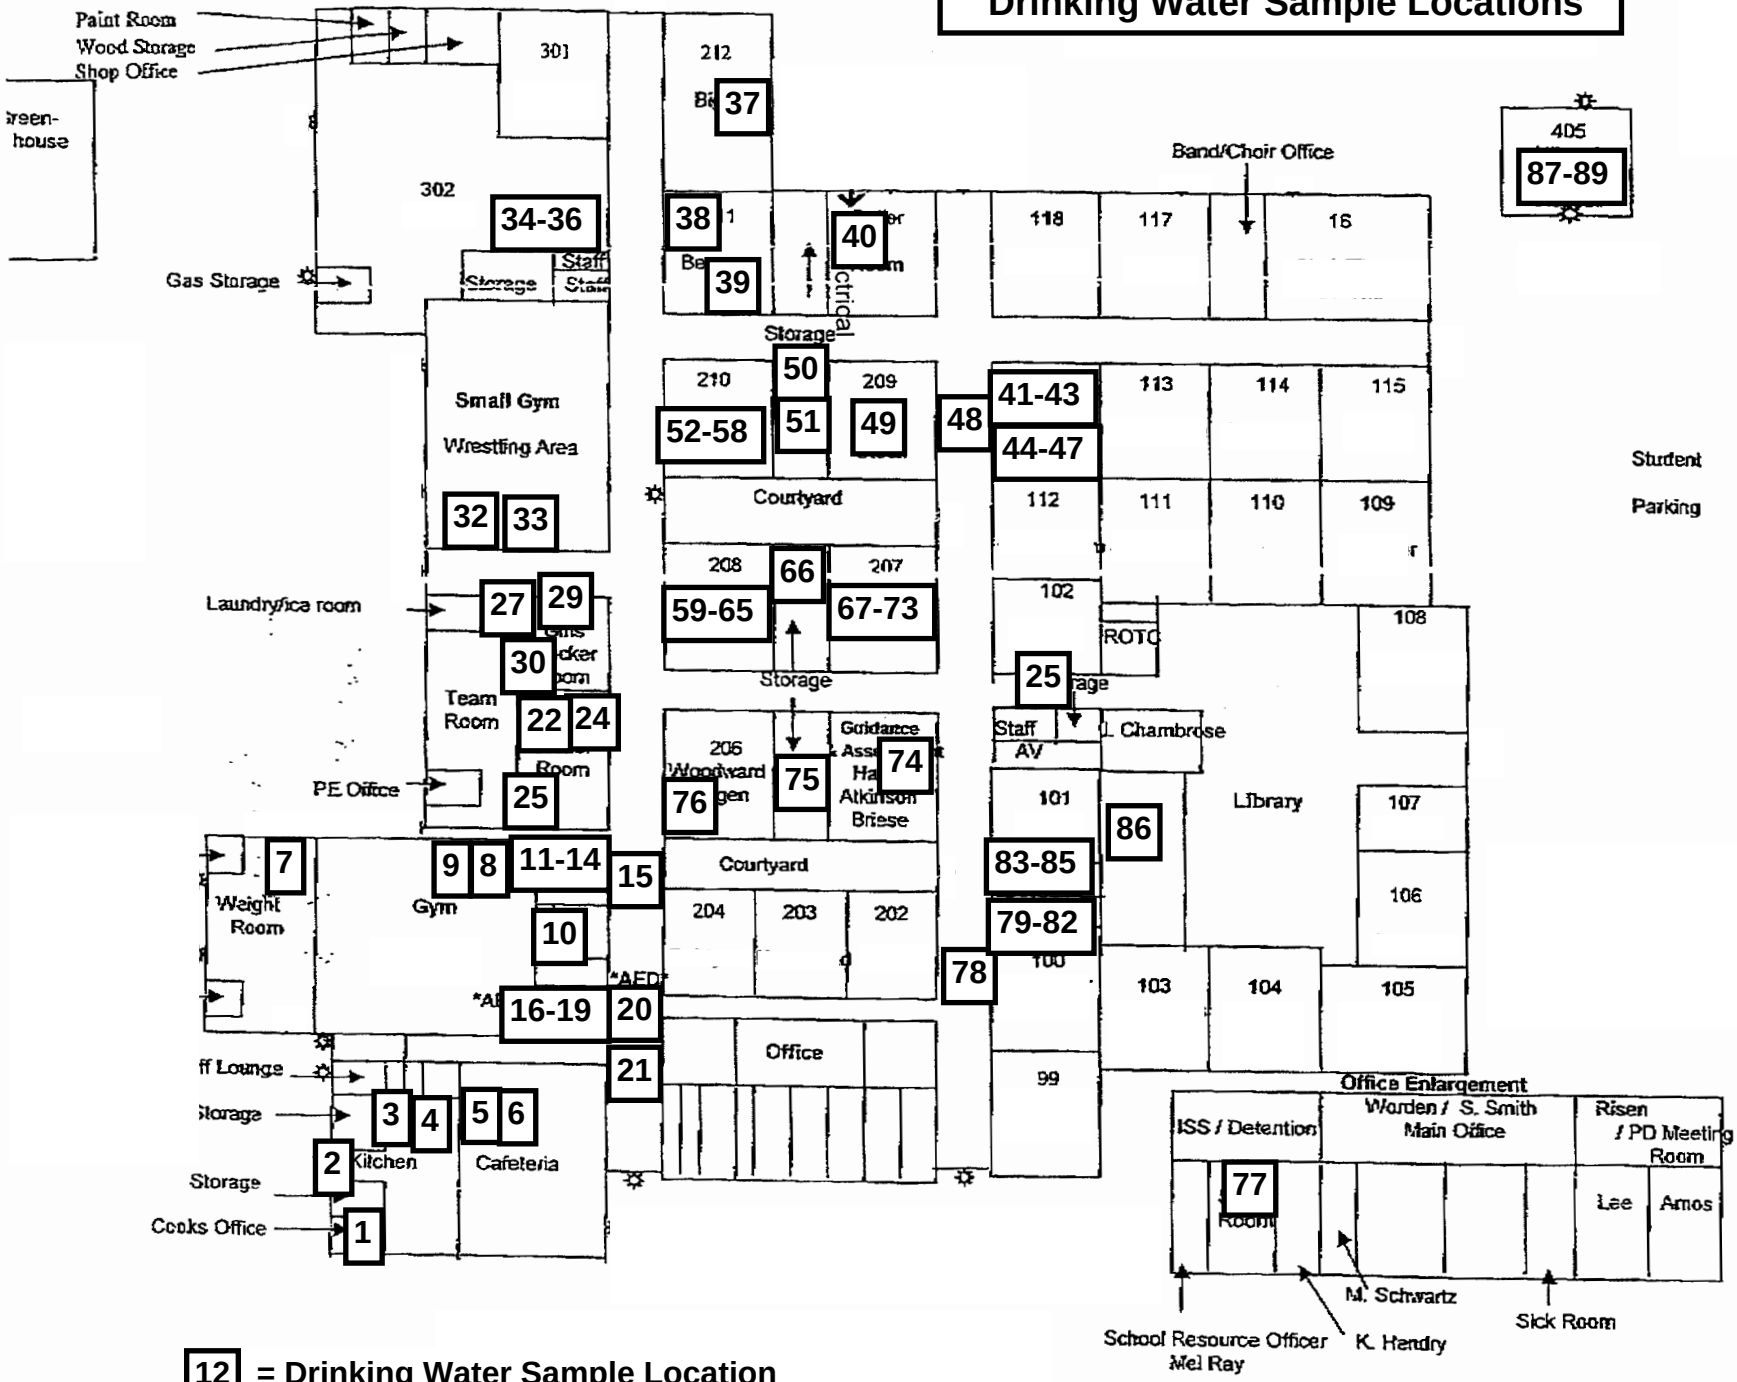
Drinking Water Sample Locations

12 = Drinking Water Sample Location
